CRREL REPORT

Air Exchange Measurements in Army Buildings

Stephen N. Flanders

July 1994

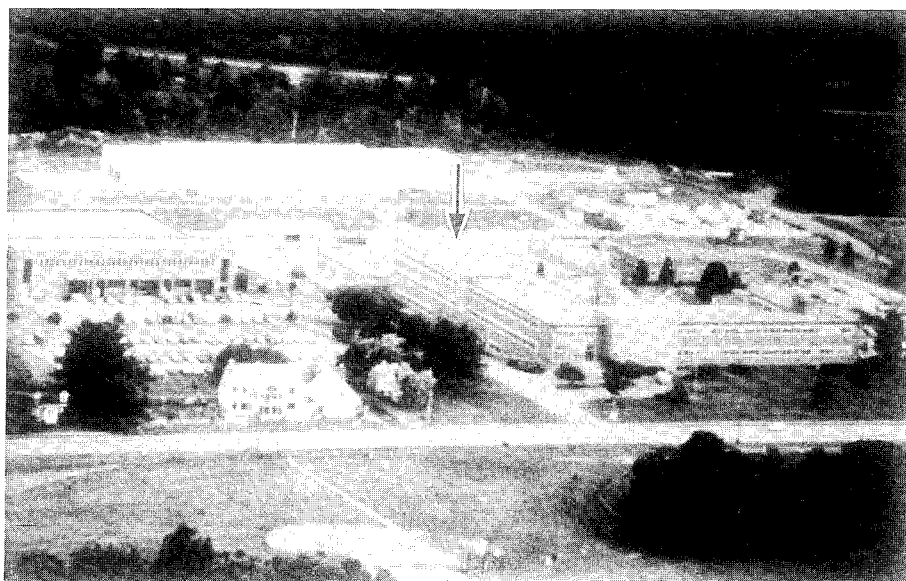
Figure 1. CRREL laboratory addition.

a. Exterior view.

b. First floor plan (not to scale).

The CRREL laboratory addition has a steel frame with metal stud infill and an exterior cladding of brick veneer. It is mechanically ventilated and air-conditioned and it abuts the original laboratory, a naturally ventilated building. The connection be-

The HVAC system comprises separate hot and cold air distribution systems (decks). Each deck has a supply air fan with dampers to control the fraction of fresh air introduced into the system with the return air. Both decks provide air to a Variable Air Volume (VAV) mixing box at each temperature-controlled zone within the building. Each occupied

Unlike many such buildings with central HVAC, the laboratory addition has operable double slider windows, which result in leaks around the sashes. The building has four personnel doors at the basement level and one each at the subbasement and second floor levels. There is a rolling overhead door at the basement and subbasement levels.

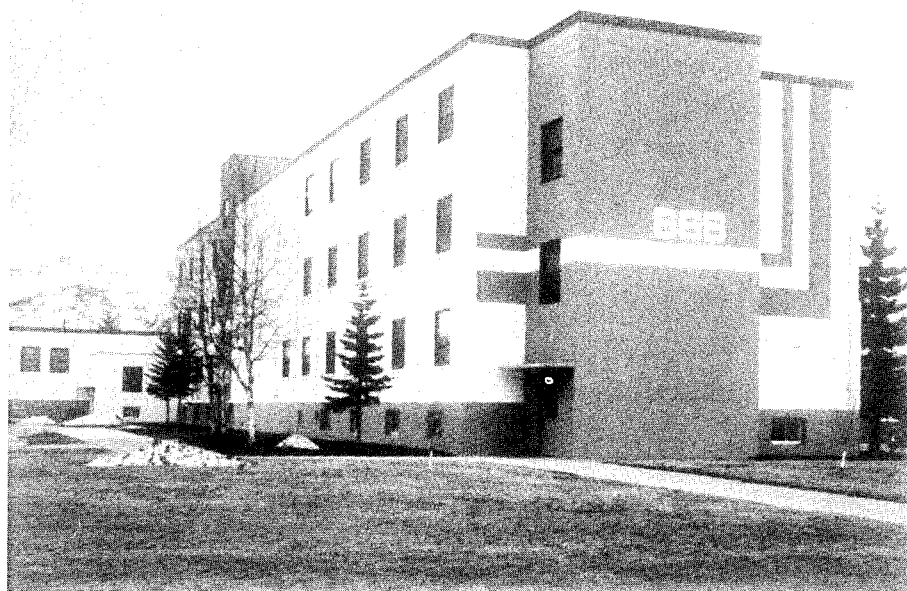
Figure 8. Building 666.

a. Exterior view.

b. First floor plan (not to scale).

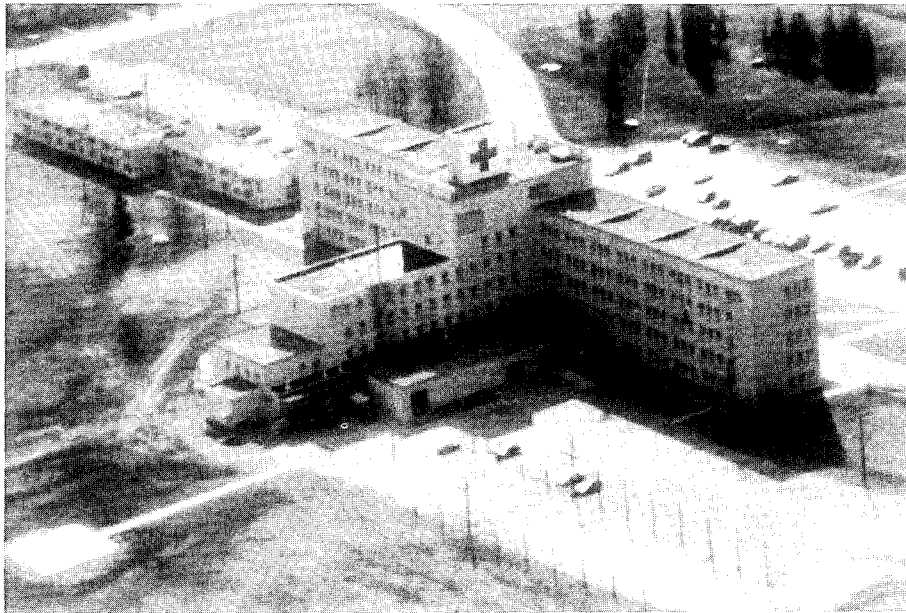
Figure 11. Bassett Army Hospital.

a. Exterior view.

b. Delivery rooms (not to scale).

c. Nursery (not to scale).

d. Operating rooms (not to scale).

Bassett Army Hospital (Fig. 11a) has perimeter steam heat and two ventilation systems, one for the operating, delivery and nursery suites, and one for the rest of the facility. A central plant provides the steam heat.

11b) and nursery suite (244 m^3 , Fig. 11c), and the sixth-floor operating room suite (271 m^3 , Fig. 11d), which are served by a single heating and ventilating system. Unlike most of the hospital, there are no windows to the outdoors. The exterior walls are opaque and have no apparent leaks.

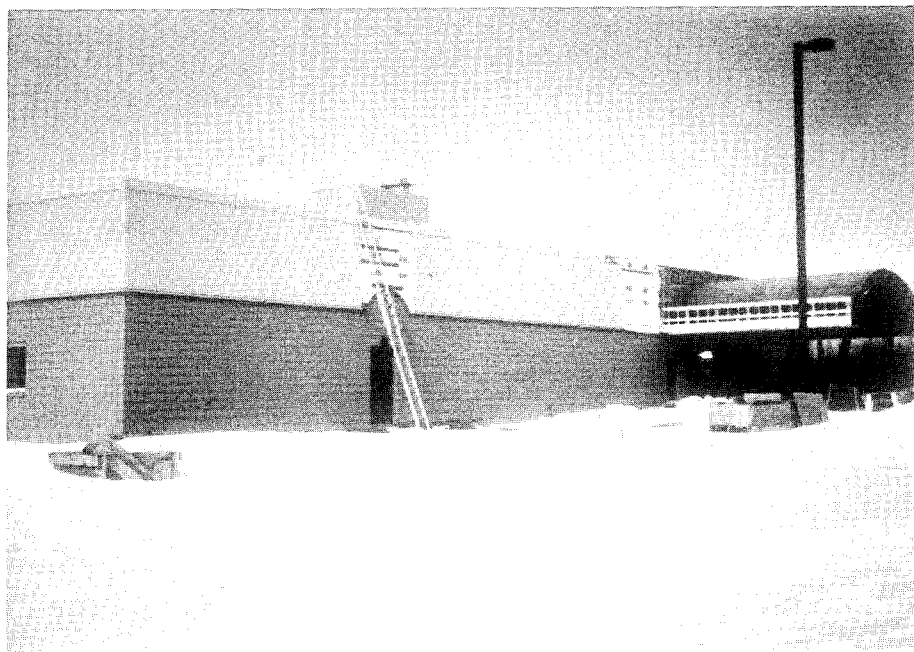
Figure 13. Bowling alley P3702.

a. Exterior view.

b. Plan (not to scale).

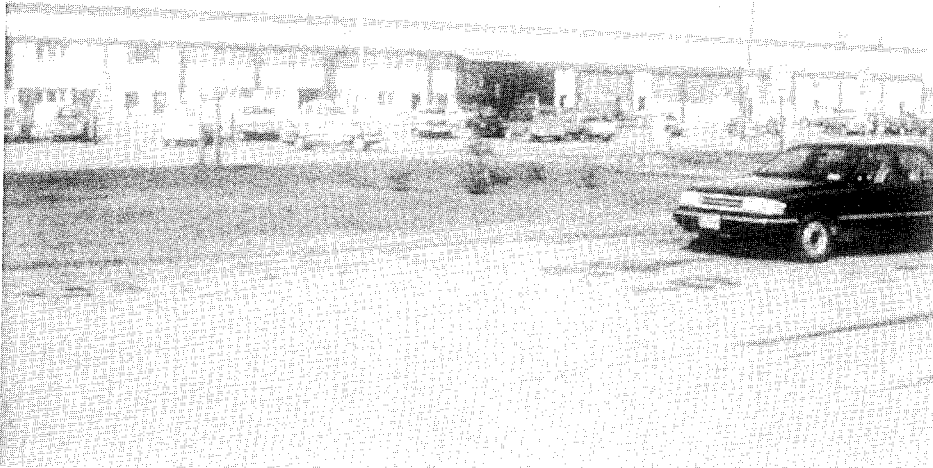
Figure 17. DEH shop, building 3015.

a. Exterior view.

b. Plan (not to scale).

The Directorate of Engineering and Housing (DEH) shop (Fig. 17a) comprises a 25×10^3 -m³ space, containing motor vehicle maintenance bays that were the subject of this study, and a two-story office and shop complex. The office and shop complex are walled off from the shop bays and have a separate ventilation system to minimize the incursion of vehicle exhaust fumes.
